TTT_Tapping-Torque-Testsystem

WinPCA3 - „Monitoring & Analysis Software”

WinPCA3 - „Screening & Analysis Software”

Practical Example

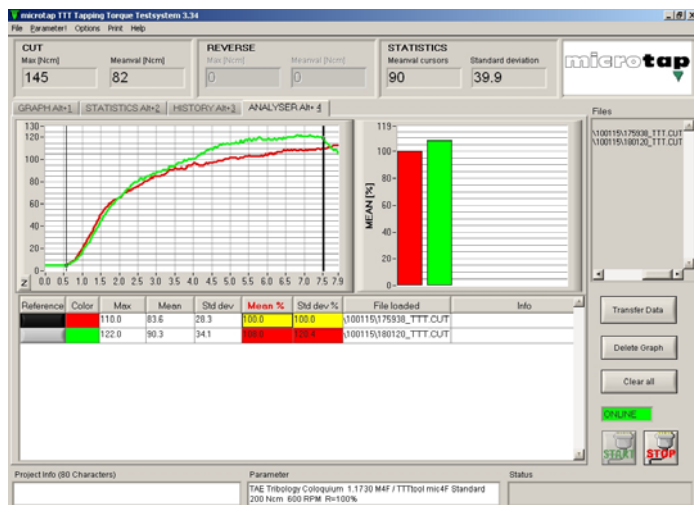
Analyzer

Measurements are compared (process quality controlled) and values displayed on the screen as a graph, with applied torque shown as a bar chart. The formulas used to find the mean & the standard deviation are as follows
